# Summary Report

## Kentucky Commercial Vehicle Safety Applications Evaluation

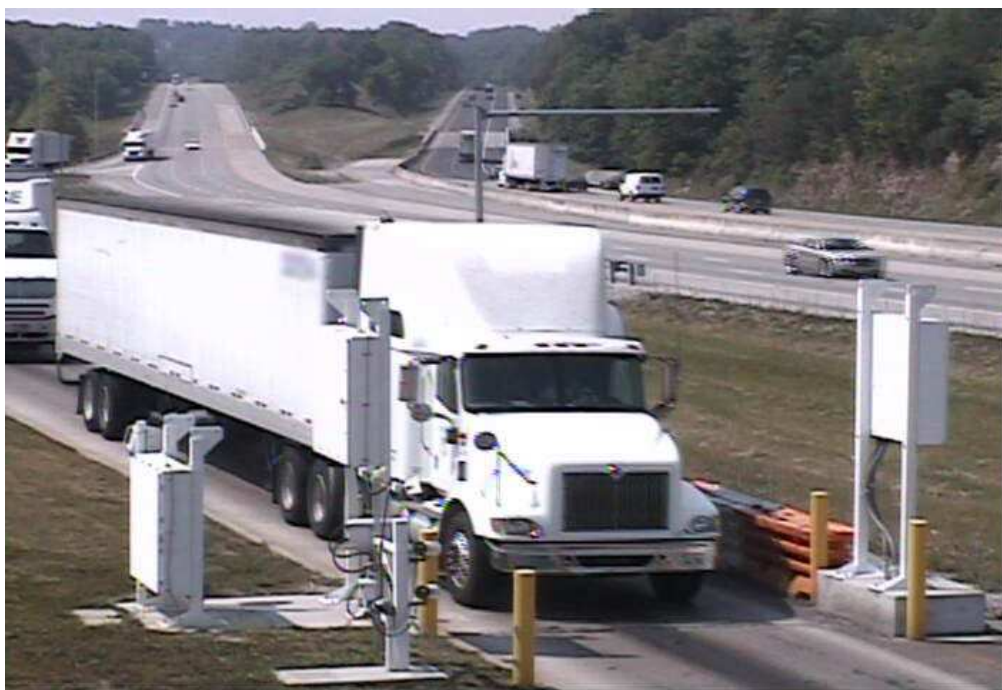
**Figure 7. Example image recorded by overhead camera at the Laurel site.**

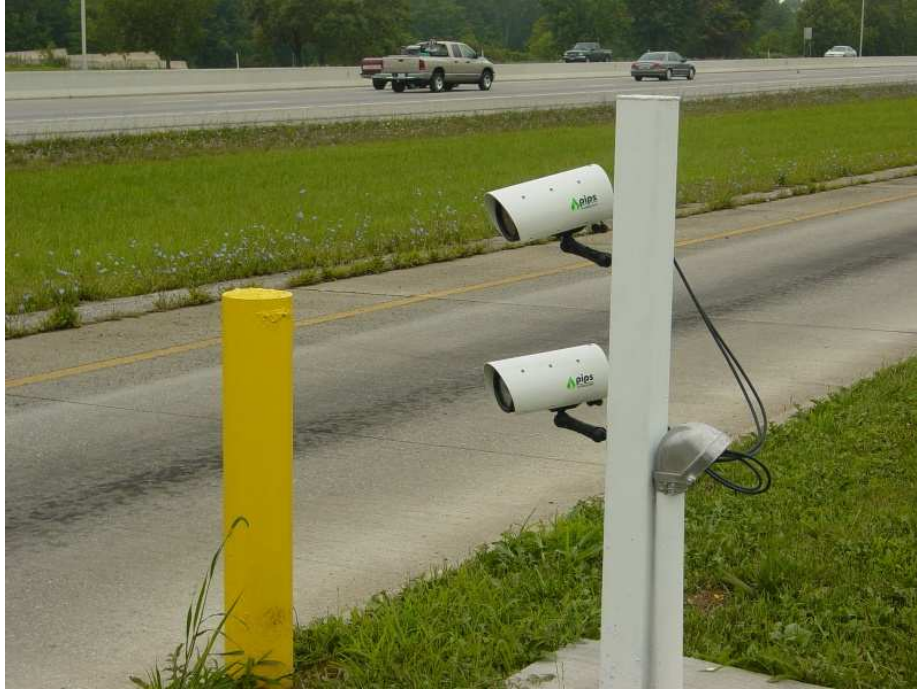
**Figure 12. Two cameras used for ALPR subsystem.**

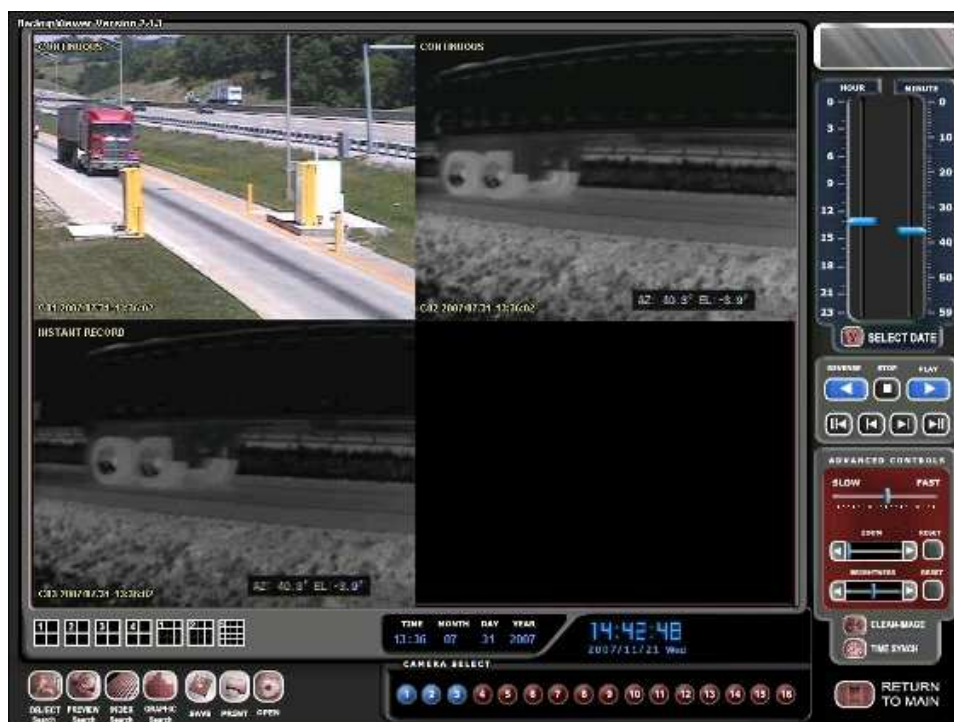
Figure 21. Image taken from Kenton IR viewer after contrast adjustment (note the time lag between the IR and color images and the inability to view the entire vehicle in IR mode).
